# Coastal erosion investigation and management options for South Mission Beach, Cardwell Shire

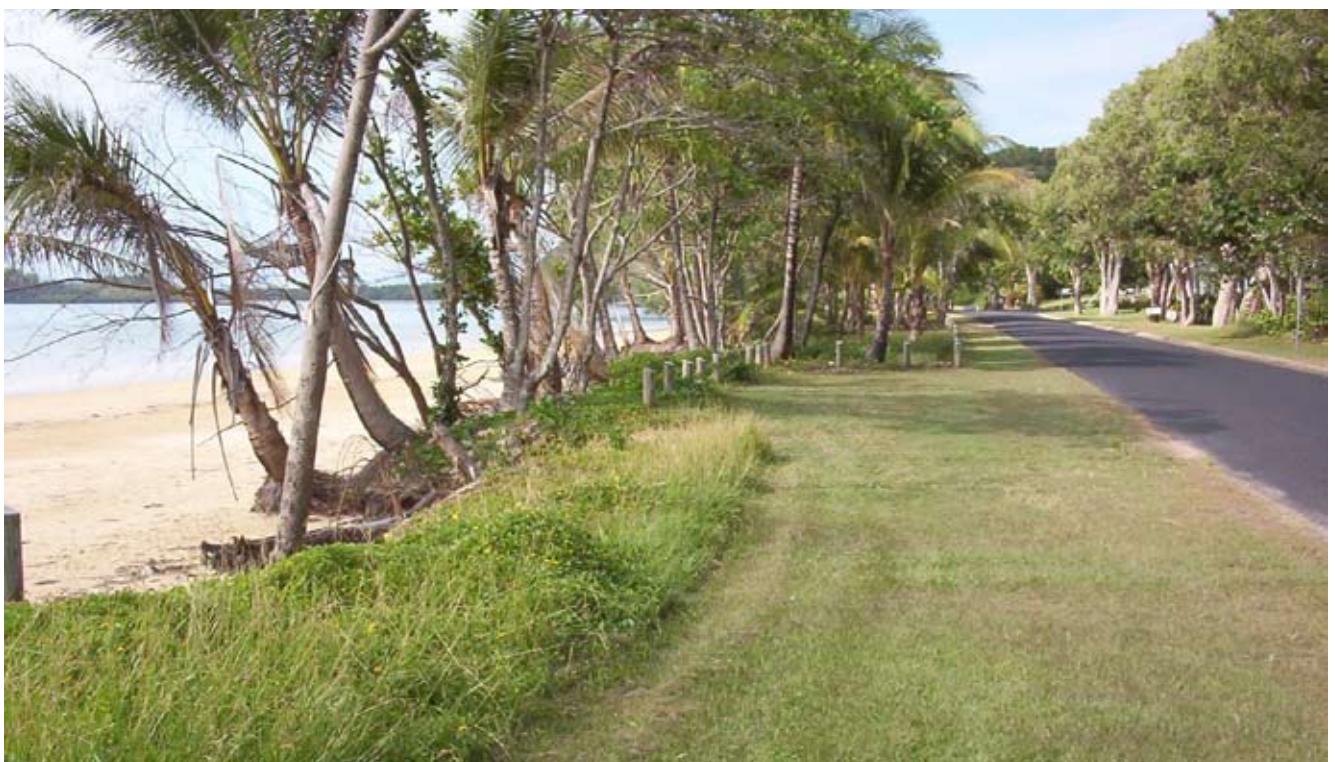
*Photo 1. Kennedy Esplanade showing the relatively narrow width of undeveloped esplanade seaward of the road. (source: EPA)*

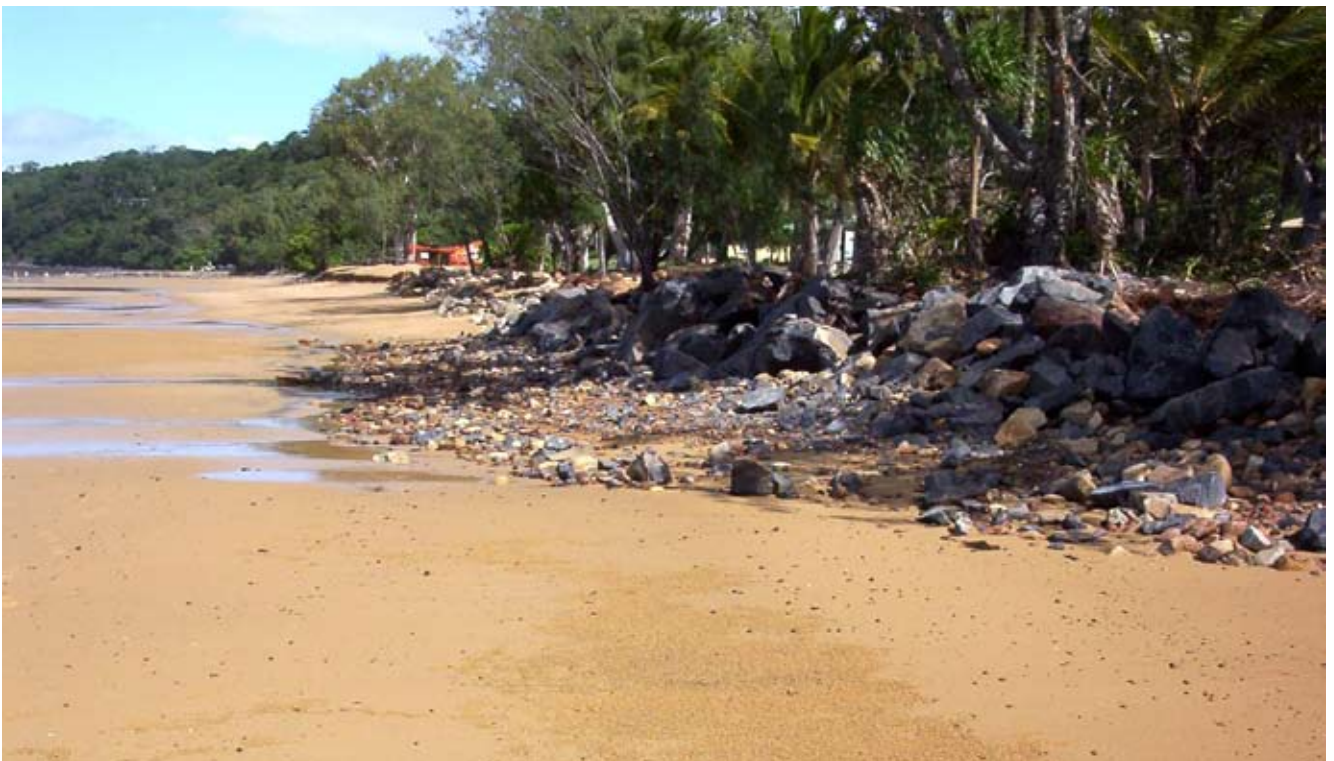
- The rock wall, for most of its length, has been poorly constructed in terms of footing depth, armor size and wall porosity, and for much of its length consists simply of dumped rock. It is considered that it would neither halt the present trend of coastline recession nor provide protection against the effects of a severe storm event. In some places the wall has slumped, smaller rock has been dispersed across the beach and the erosion scarp has retreated behind the wall alignment.

- Construction of the wall on the erosion scarp means that there is little, if any, sand dune buffer left between the rock wall and the beach. This leaves the wall continuously exposed, which reduces the visual amenity of this prime recreational asset.

*Photo 2. Poorly constructed rock wall at the southern end of South Mission Beach. (source: EPA)*

An upgraded revetment wall would be required to reduce the present erosion risk, and if the Council decided to proceed, the EPA would recommend that the wall be designed to withstand a minimum one in 50 year average recurrence interval storm event (see Table 1). The Council would need further structural design advice before proceeding to actual construction of a wall. As a cost indicator of an adequately designed revetment, a recently constructed rock revetment wall at Holloways Beach at Cairns cost approximately \$3000/m. Optimizing this design to local conditions as detailed below may reduce this cost to under \$2000/m.

- iv) The southern section of rock revetment wall from the boat ramp to Jackey Jackey St should be upgraded to a standard appropriate to withstand damage from a severe storm event with an ARI of 50 years minimum. Rubble walls to the north should be removed and the reconstructed dune relied upon as the primary protection against wave attack and sea erosion.

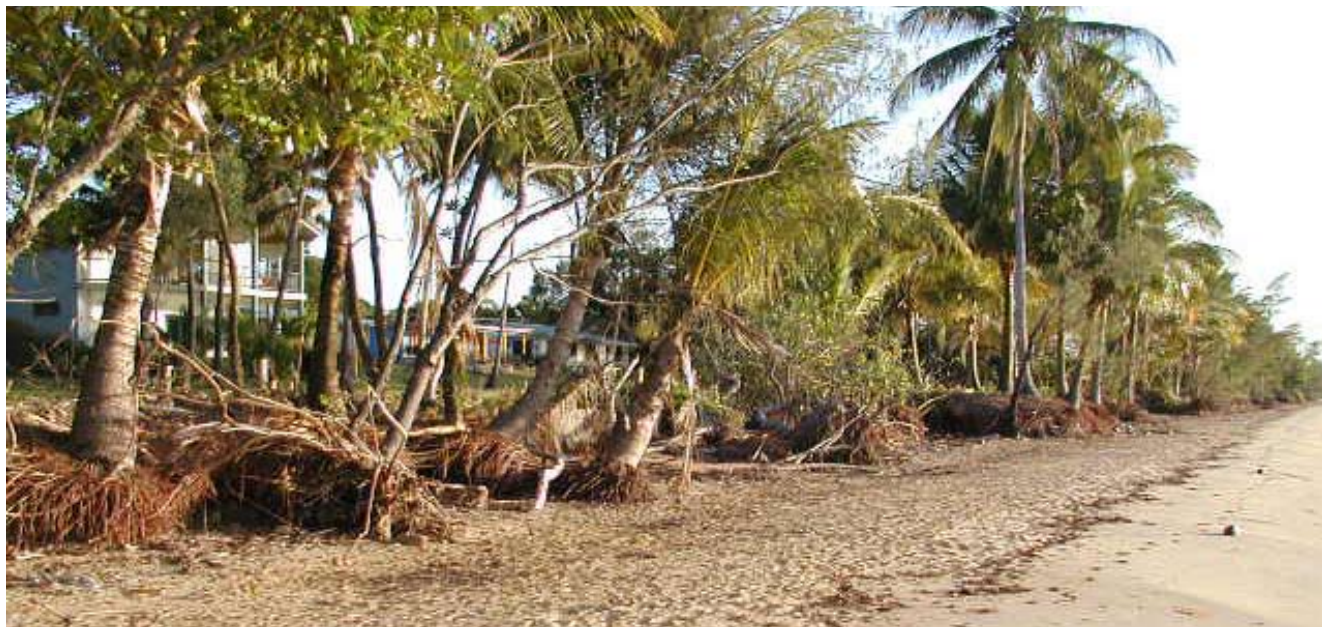
*Photo 3. Beach condition in June 2001 following sea erosion. (source: EPA)*

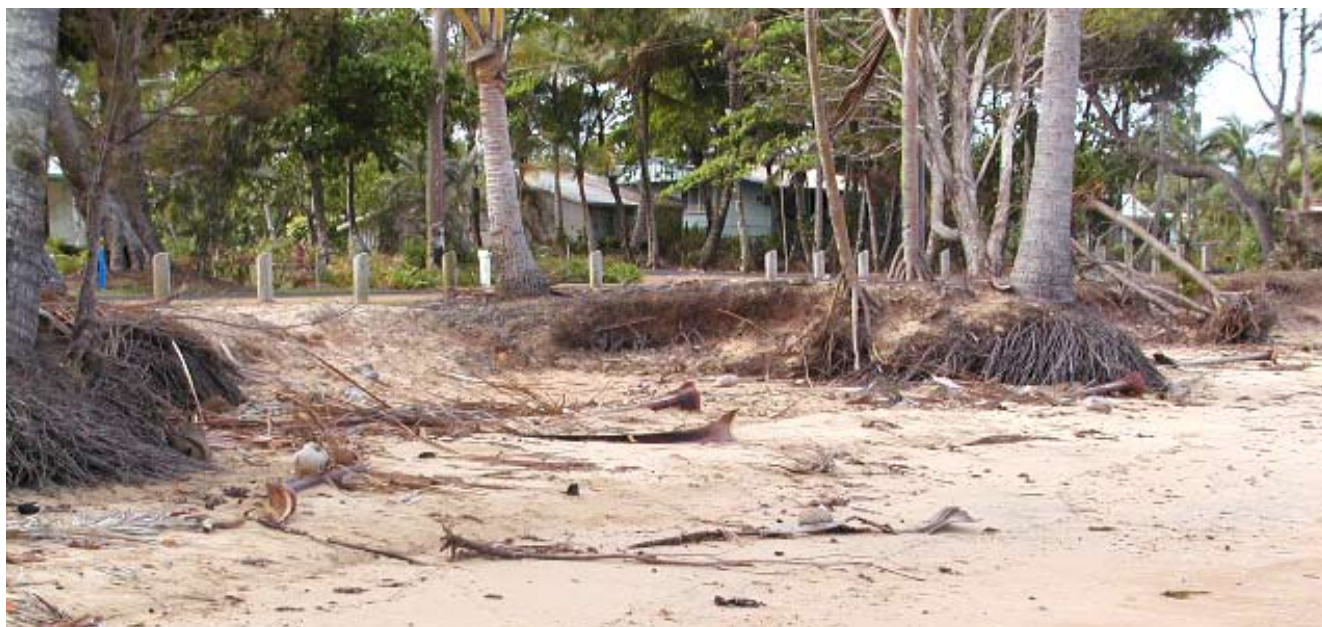
*Photo 4. Beach condition in November 2003 following sea erosion. (source: EPA)*

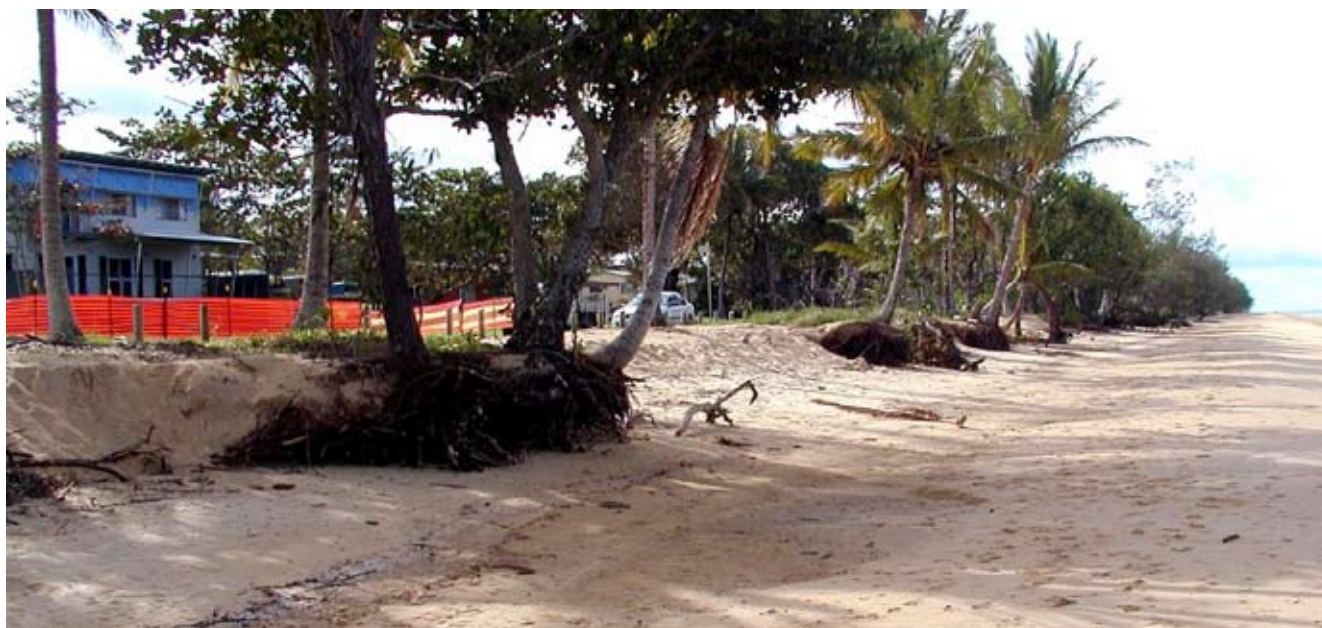
*Photo 5. Beach condition in May 2004 following sea erosion in March 2004. (source: EPA)*

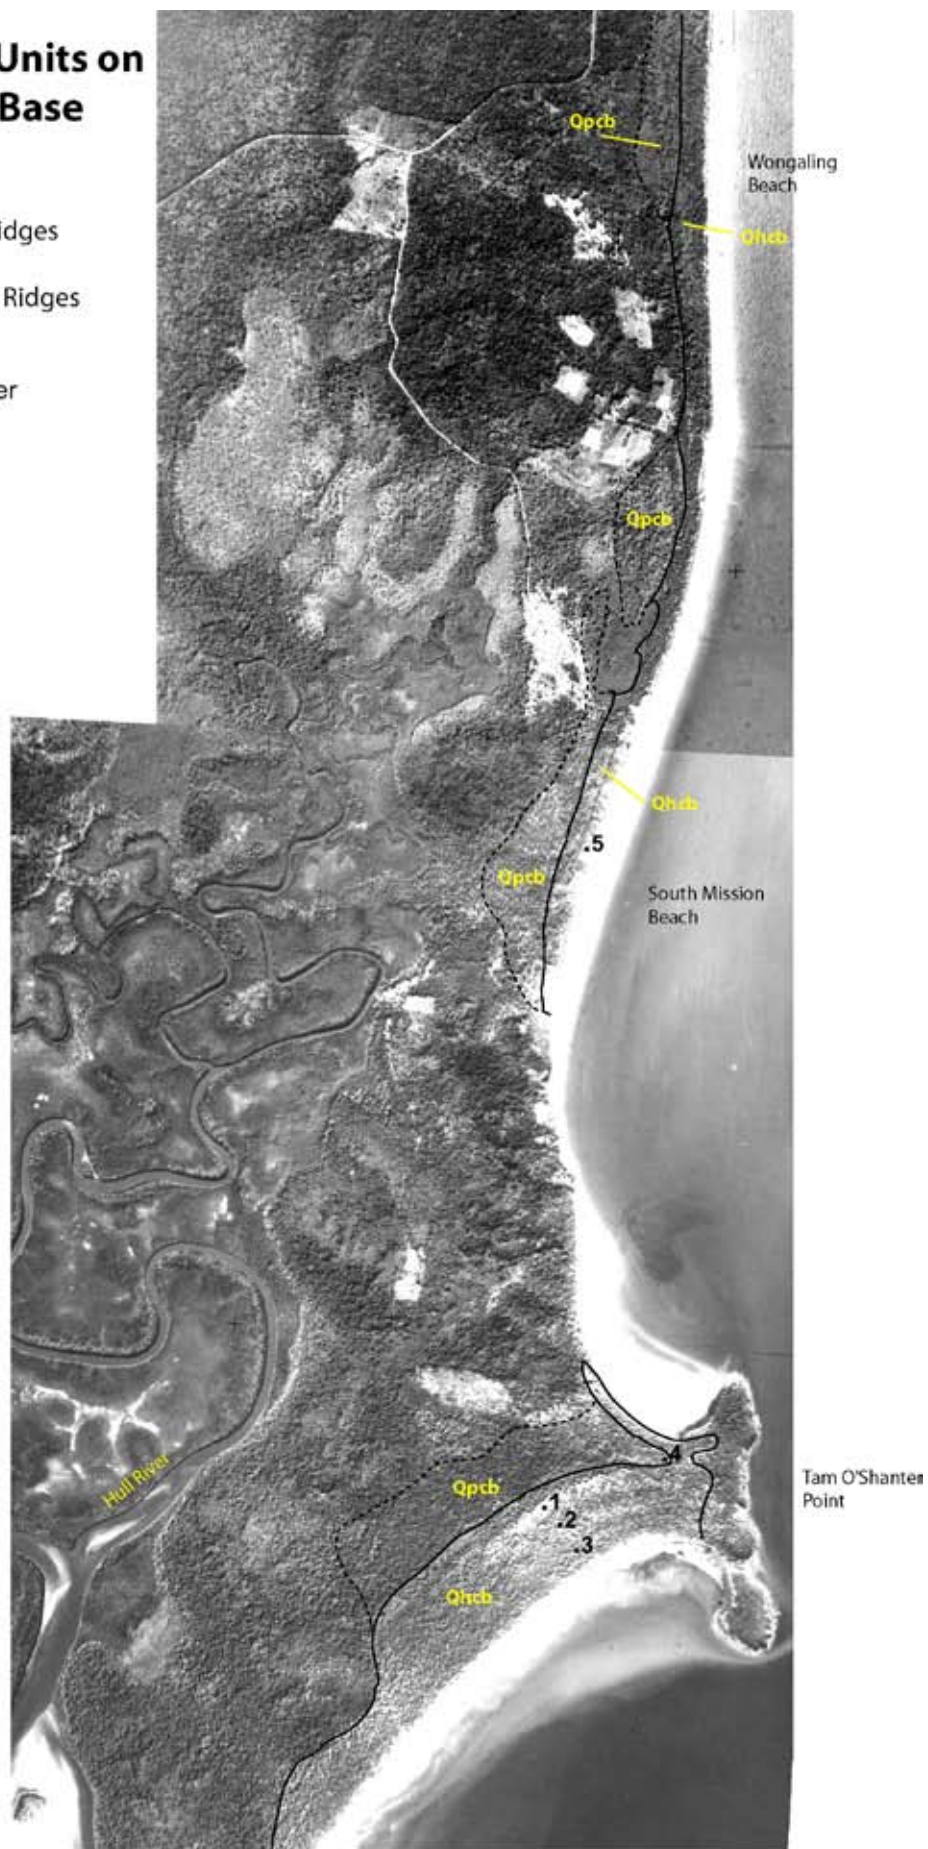
- Qhcb** Holocene Beach Ridges
- Qpcb** Pleistocene Beach Ridges
- .1** Soil sample site location and number

Figure 2. Morphostratigraphic units of the dune areas from the Hull River to Wongaling Beach – 1951 photography. (source: EPA)

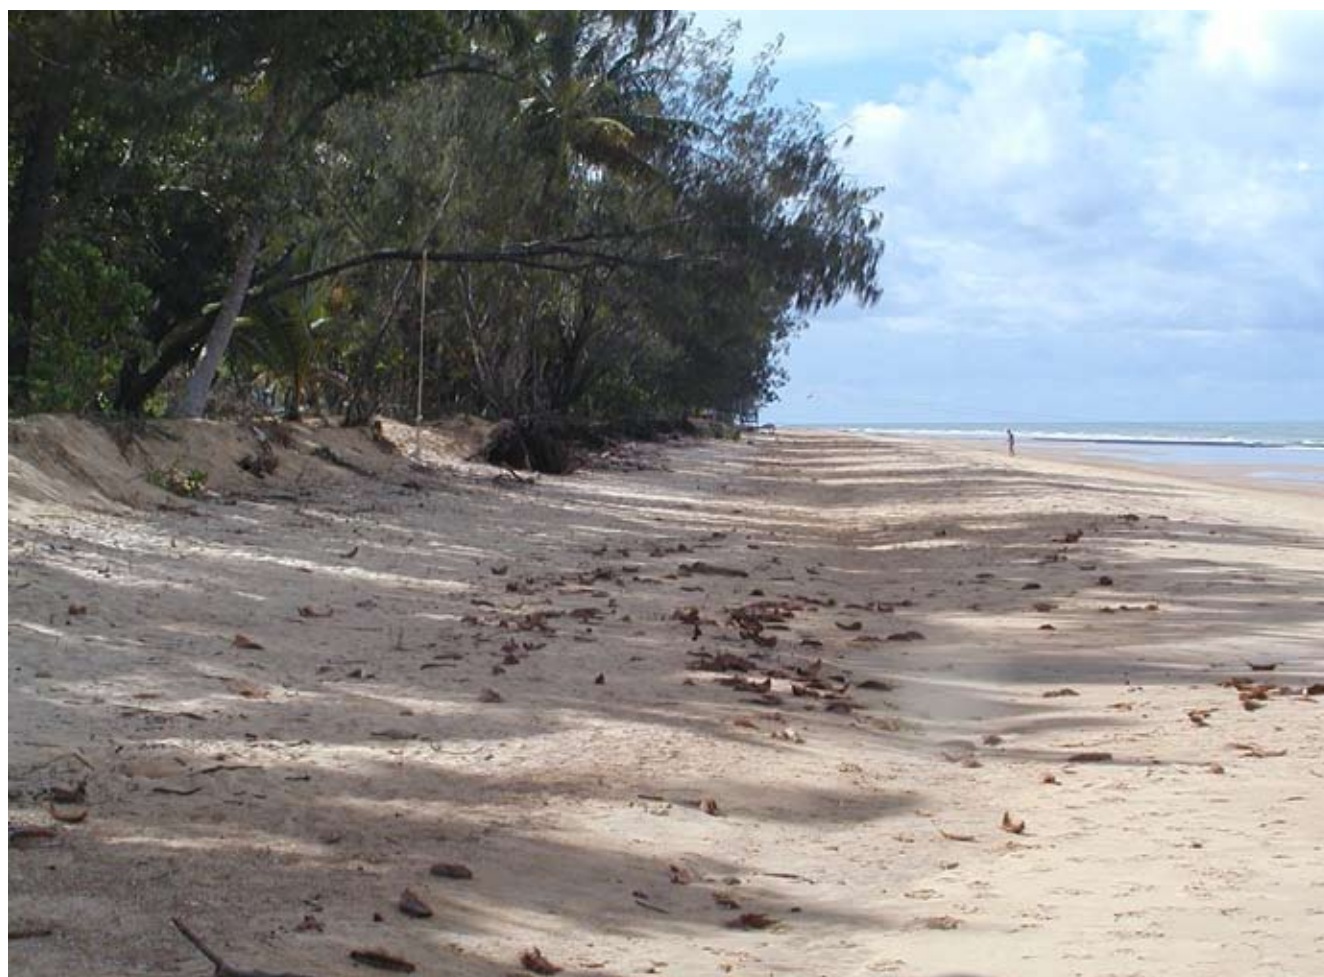
*Photo 6. Northern end of South Mission Beach following erosion in March 2004. Note the broad intertidal zone and high-tide bar. It would be expected that this bar will move up the profile in calm weather and rebuild the dunes. (source: EPA)*

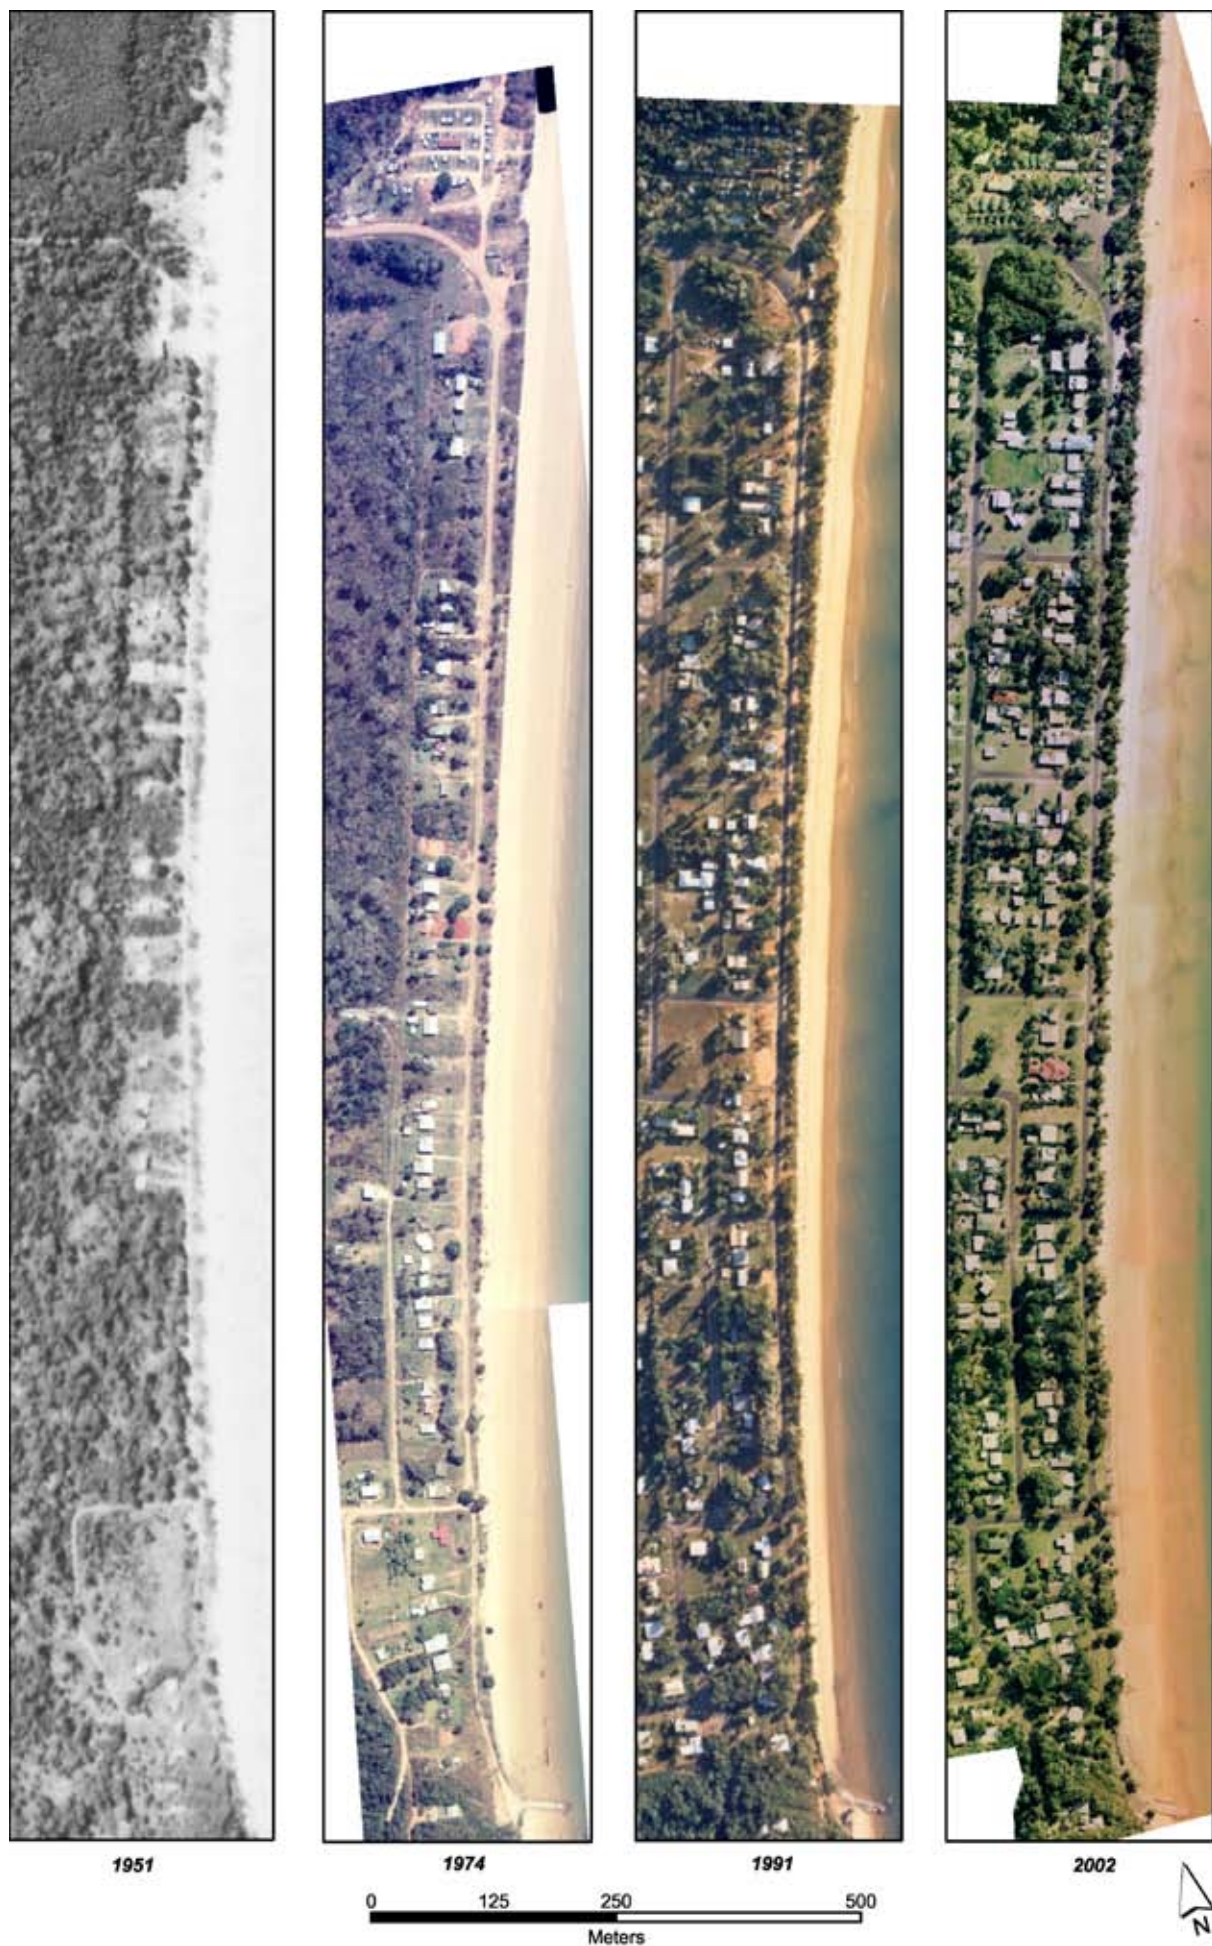
Figure 4. Historical aerial photos of South Mission Beach 1951 to 2002. (source: EPA)

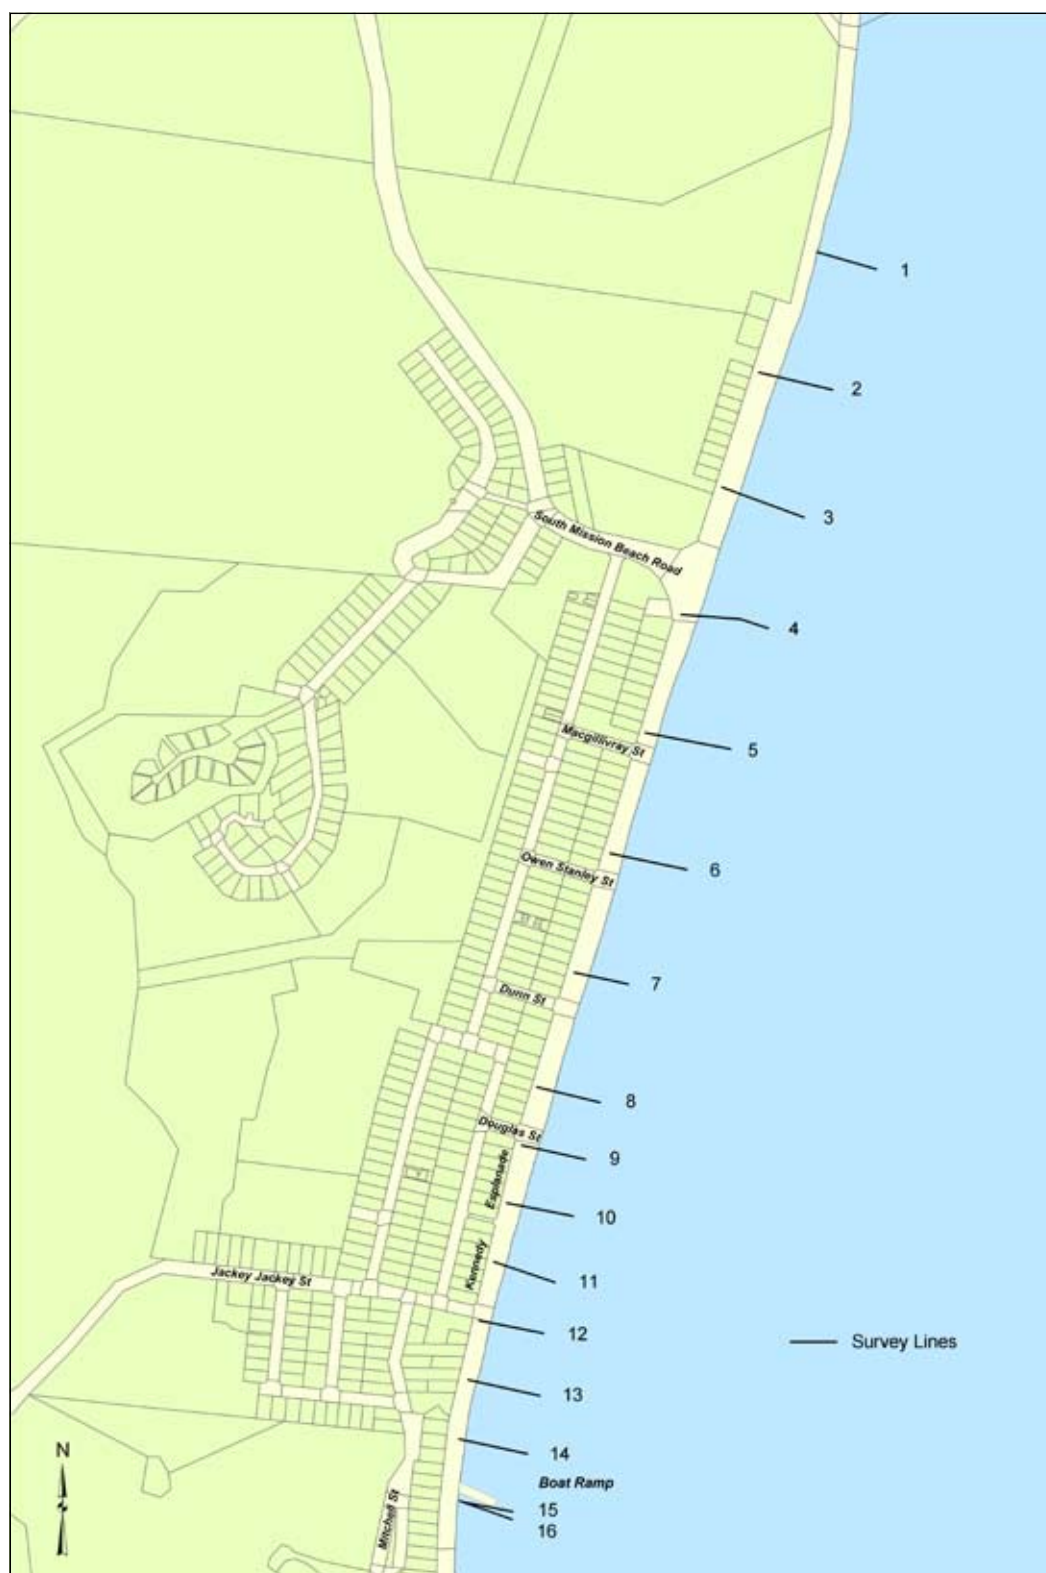
Figure 6. Location and number of survey lines.

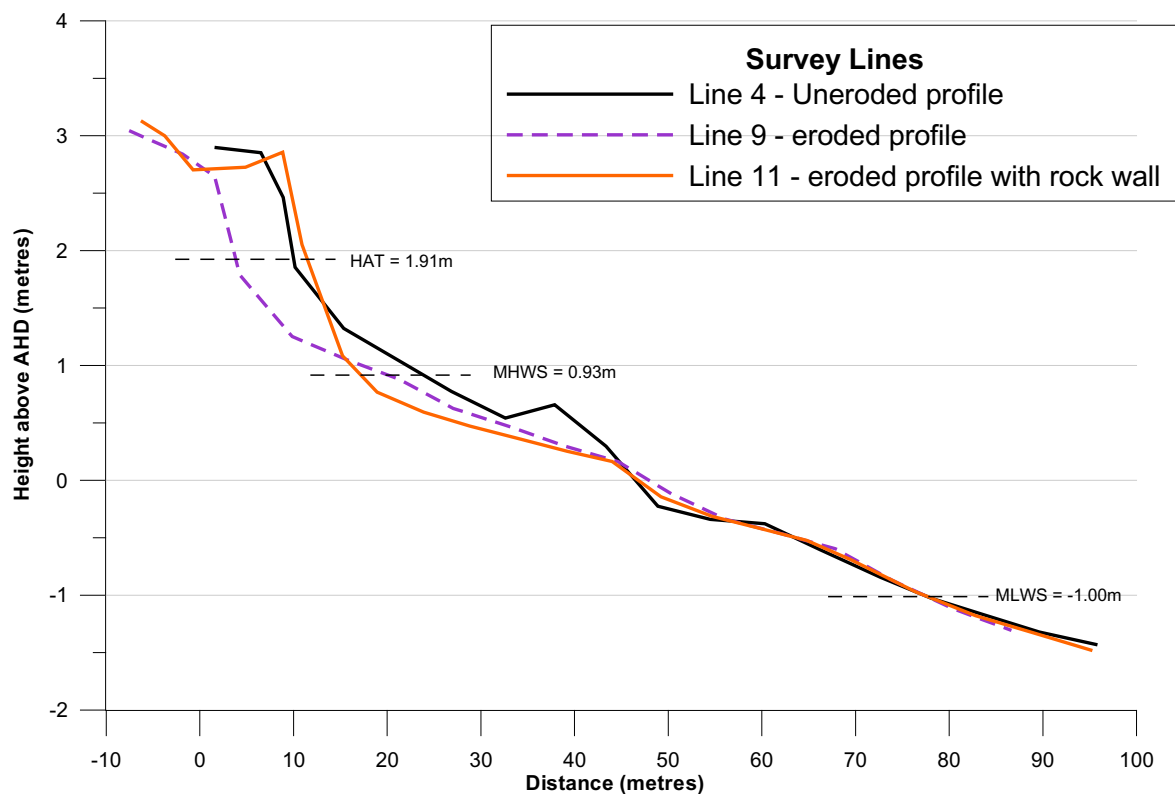
Figure 8. Typical beach profile

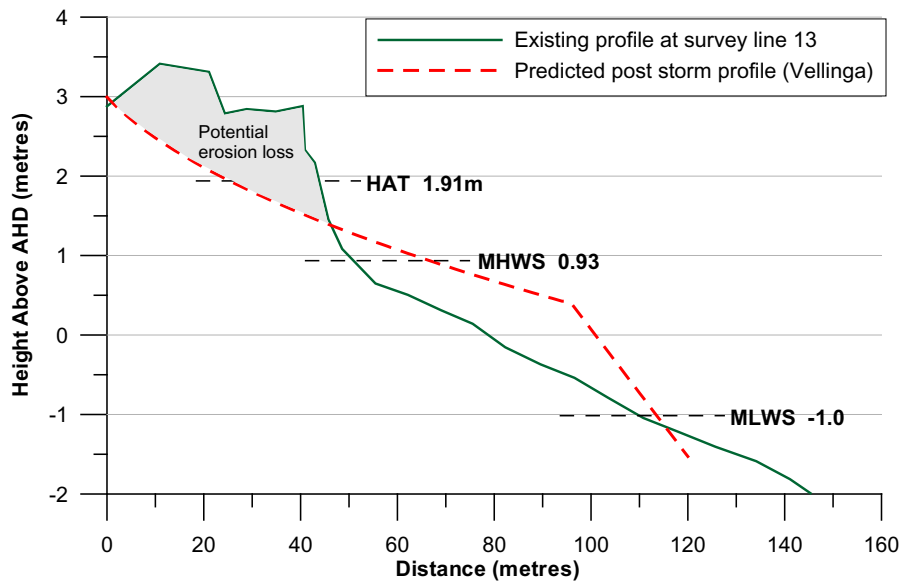
The analysis results show a recession at the toe of the frontal dune in the order of 45m is required to achieve an equilibrium beach profile at the elevated water level (figure 10). The actual amount of recession will depend on the duration of the elevated water level and the tidal influence at the time. Such a recession event may not occur as a single event and could result from the cumulative effect of a series of events over a short time period. This would provide the opportunity for short-term remedial actions, such as sand pushing from the intertidal zone to the upper beach.

Figure 10. Estimated short-term beach profile response to a 1 in 100 ARI storm event based on Vellinga 1995).

- ii) increase the width of the dunes to create a wider buffer zone seaward of the road. Figure 10 demonstrates that an extreme cyclonic event (1 in 100 ARI) may cause erosion of the dunes and a landward recession of the coast by up to 45m. An analysis of the existing dune width indicates that the dunes would have to be increased in width seaward of the road by up to 35m so that this erosional loss could be accommodated within the dunal zone. The sand volume to construct this buffer zone is estimated at 180,000m<sup>3</sup> for the length of South Mission Beach. A lesser sand volume could be considered to increase the level of protection against lower intensity storm events, and would also assist in protecting the remaining trees on the Esplanade. An increase in dune width to 20m seaward of the road edge is considered to be a reasonably functional width increase. This would require an additional 20,500m<sup>3</sup> of sand placed on the southern and central section of the beach. A detailed description of sand quantities required and placement location for an increase in dune width is given in table 3.

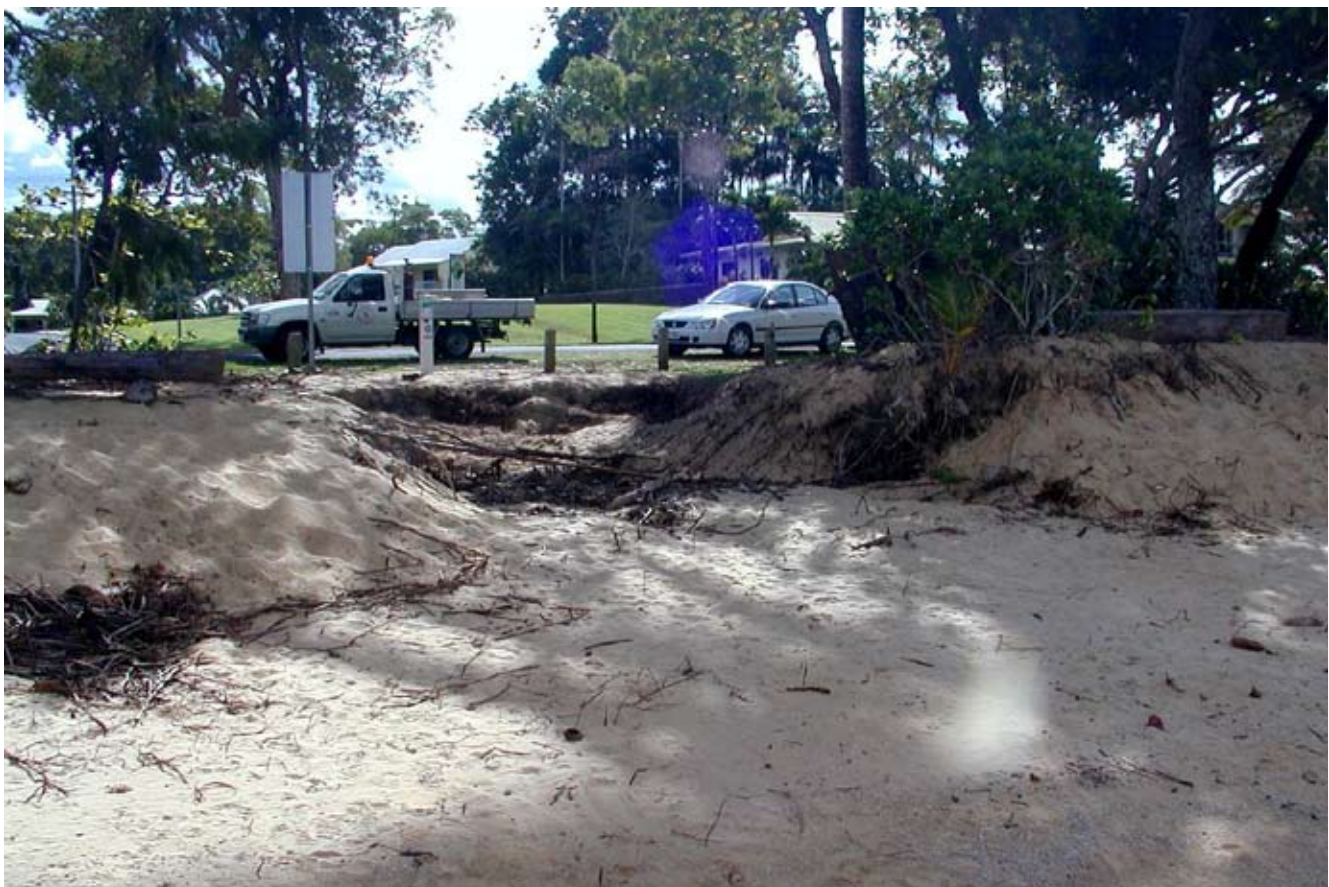
The sump type disposal system does not appear to have the capacity to handle intense rainfall events which cause system overflows. This is observed to result in ponding of water behind the dune crest, and locally concentrated surface flow. This system may also have a limitation in that the sump will locally elevate ground water levels and where this is near the erosion scarp face, the sand becomes fluidised and is more susceptible to erosion. As ponded water breaches the dune crest significant scour holes are formed, which can further concentrate wave erosion (see photo 7).

Photo 7. Scour channel through the foredune caused by stormwater overflow, May 2004. (source: EPA)

The direct discharge of storm water to the ocean across the beach appears to be the only viable alternative at this location to minimise this impact. However, unless managed correctly, disposal of storm water to the upper beach has the potential to cause extensive local scour. Suitably designed outlet structures would be required to minimise problems.

Council will need to seek further design advice regarding this matter. It is noted that a number of new products have been developed utilizing geotextile materials that may be of use including sand filled containers, and scour aprons.

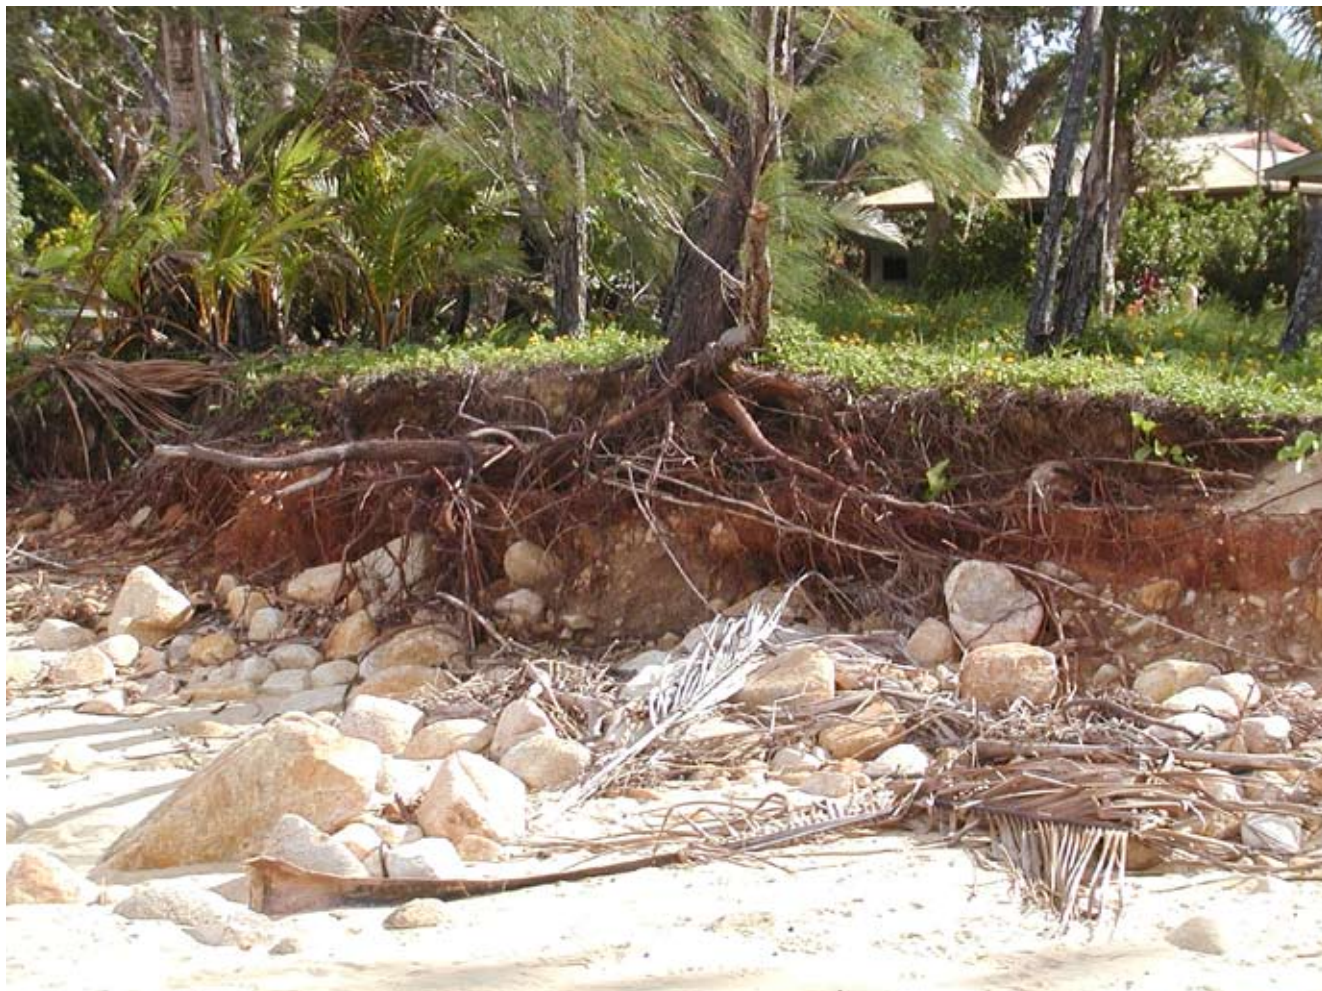
*Photo 8. Rock and soil fill material on the esplanade exposed by dune erosion. (source: EPA)*
